INSURED/APPLICANT NAME HECTOR RODRIGUEZ APPLICATION / POLICY # \_\_\_\_\_  
 ADDRESS INSPECTED: 857 SW MCCOMB AVE, PORT ST LUCIE, FL 34953  
 ACTUAL YEAR BUILT: 1986 DATE INSPECTED: 09 JUN 16

**ROOF - WITH 2 ROOF PHOTOS, THIS PORTION CAN TAKE THE PLACE OF THE ROOF CONDITION CERTIFICATION FORM (CIT RCF-1)**

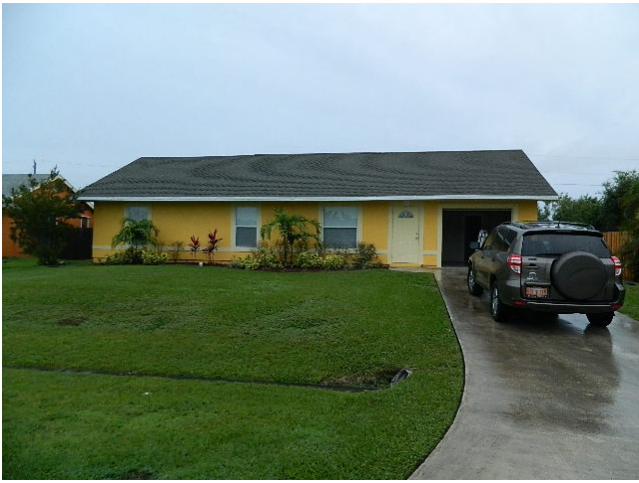
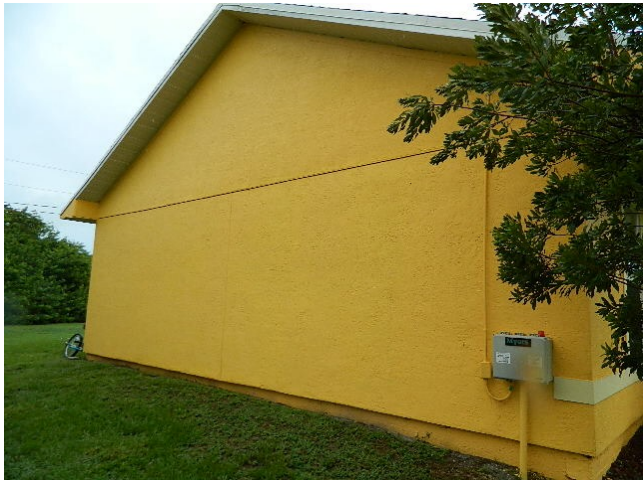
Front and left side elevation

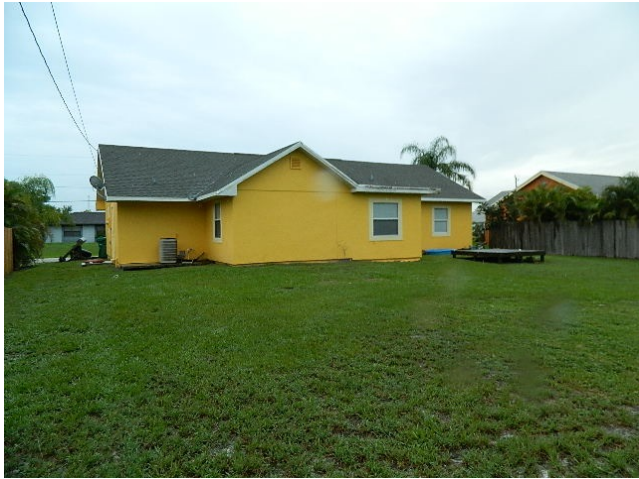
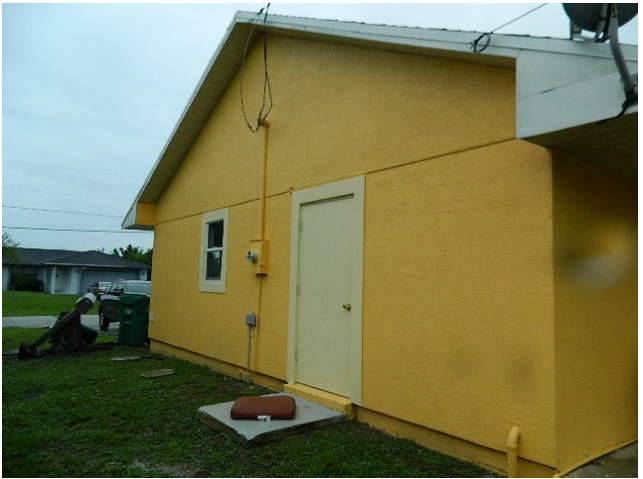
Rear and right side elevation

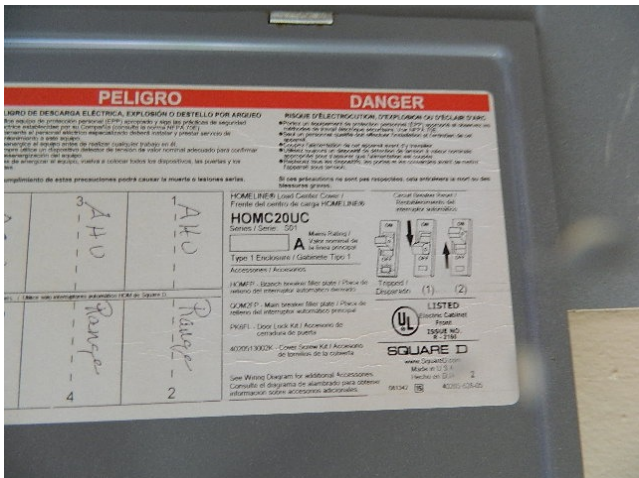
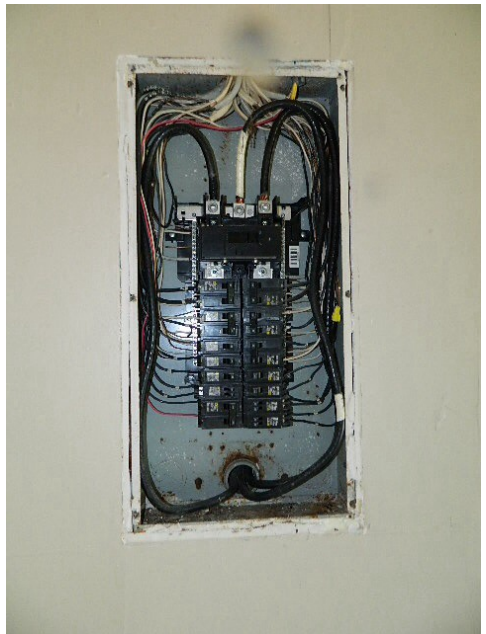
Square D panel and exposed panel

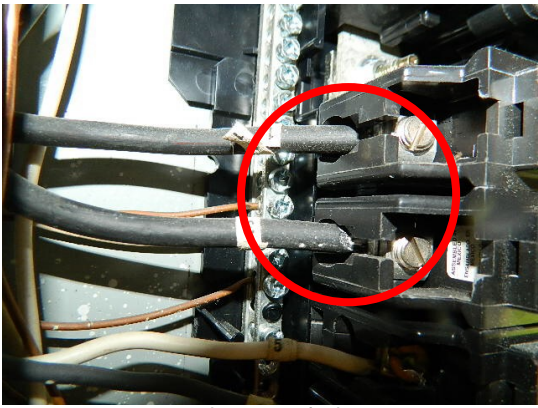
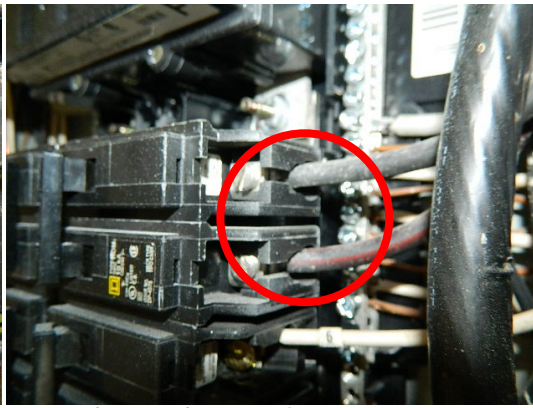
Observed two MULTI STRAND, not single strand aluminum circuits. Possible over heating of main at the panel. Consult with a licensed electrician and repair or replace as needed. Roof ridge vent is loose, missing a piece of ridge cap and minor damage to some shingles due to tree branches.

Multi strand aluminum wiring circuits observed in panel

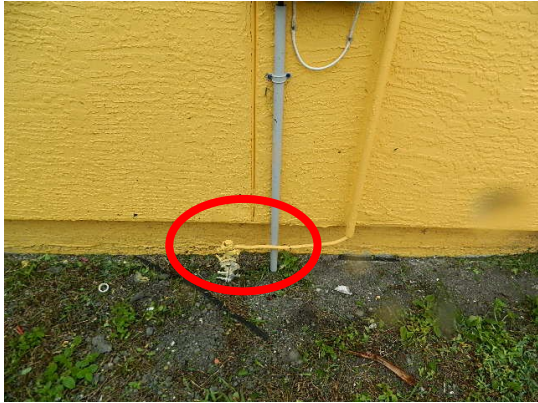
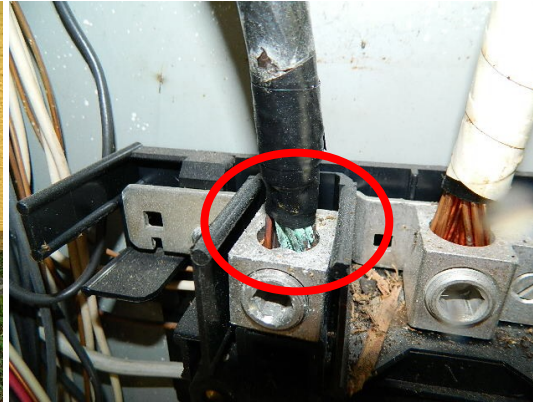
Electrical panel main ground and possible overheated main/oxidized

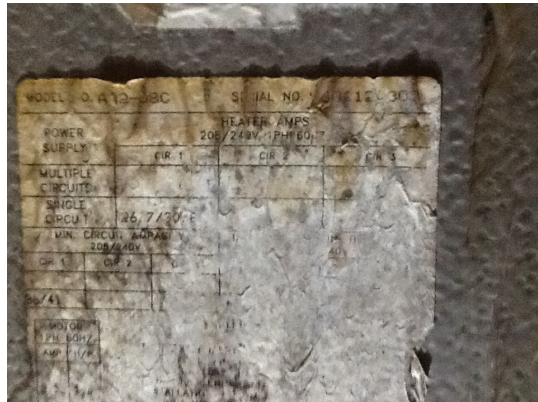
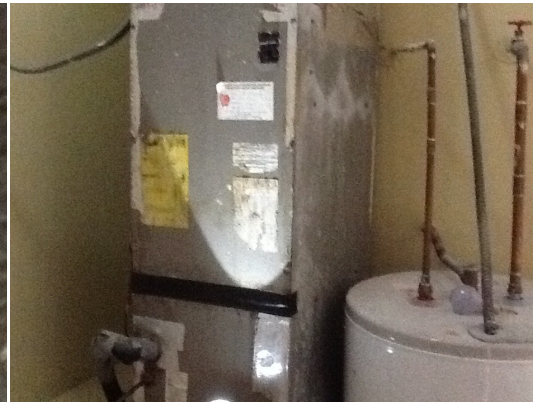
Data plate and HVAC air handler, located in the utility room, data plate hard to read but believe the unit is a 1996 unit.

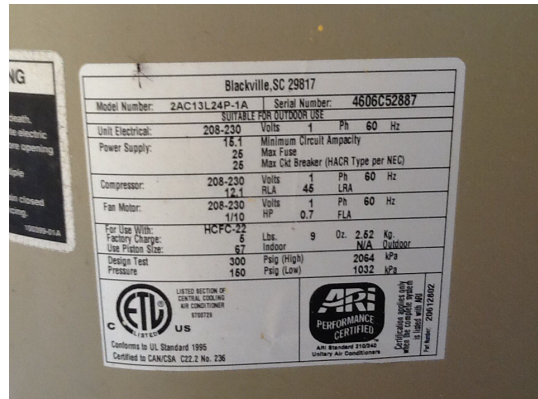
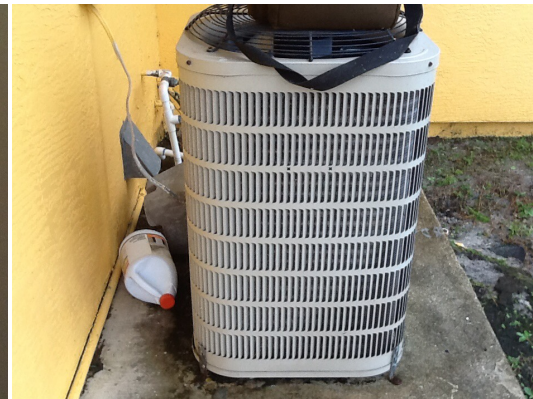
Data plate & HVAC compressor

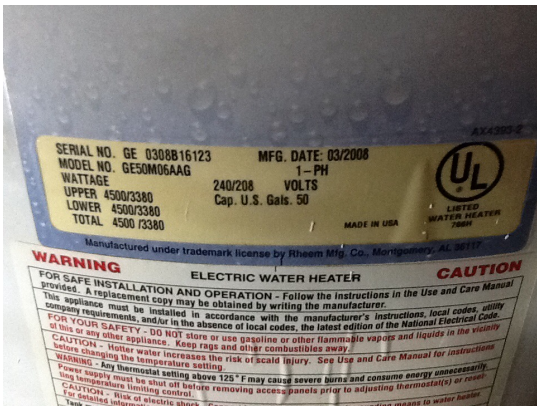
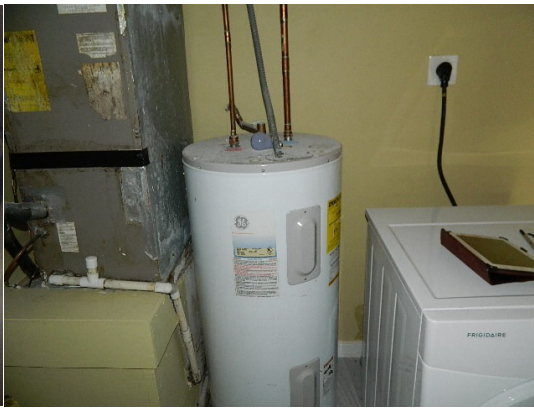
Water heater data plate and unit located in utility room

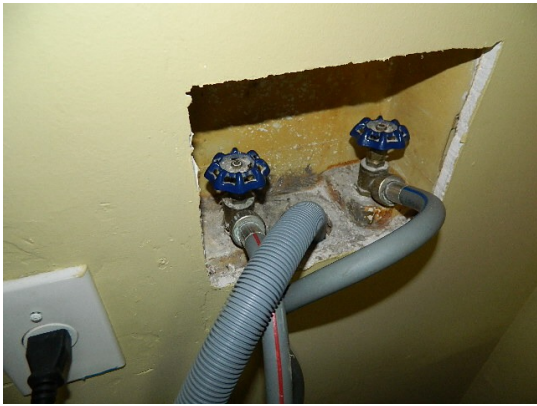
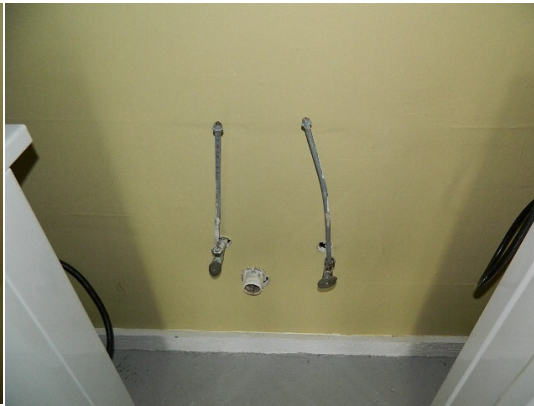
Washing machine and utility sink water shut off valves

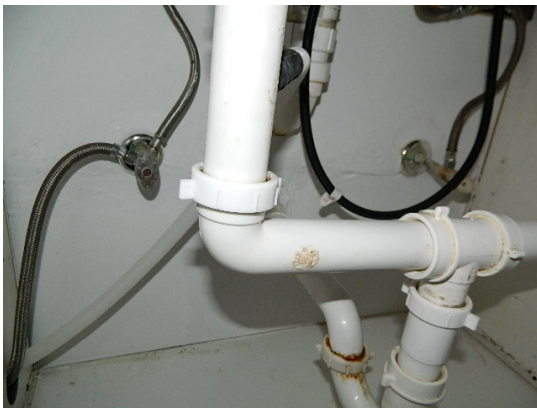
Kitchen sink water supply shut off valves

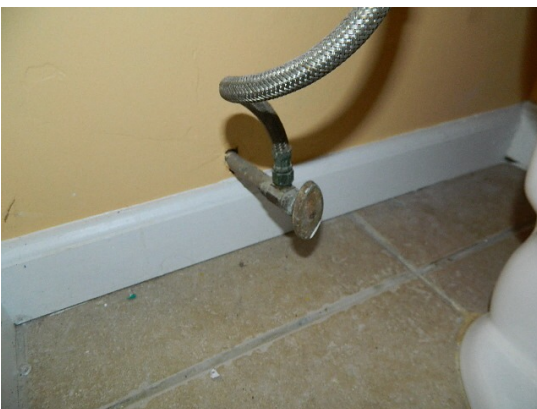
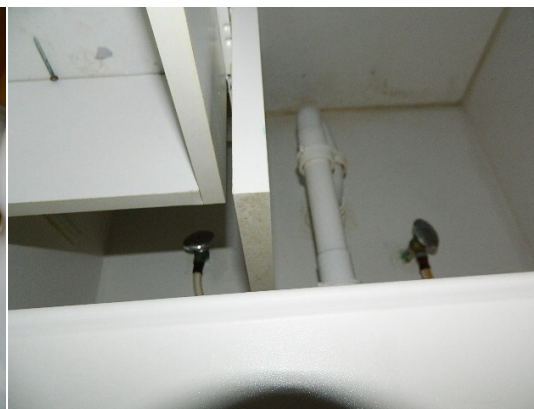
Hall bathroom toilet and vanity water supply shut offs

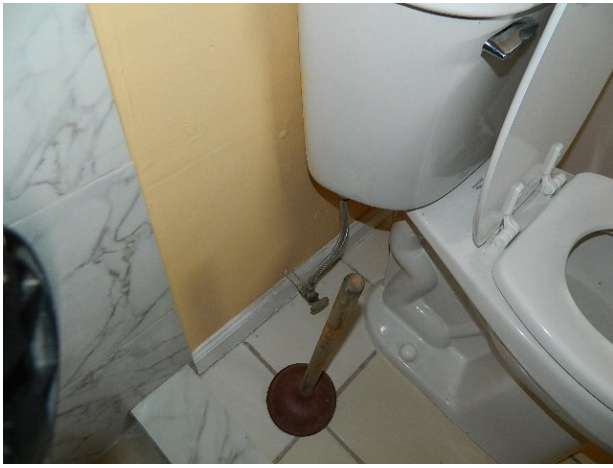
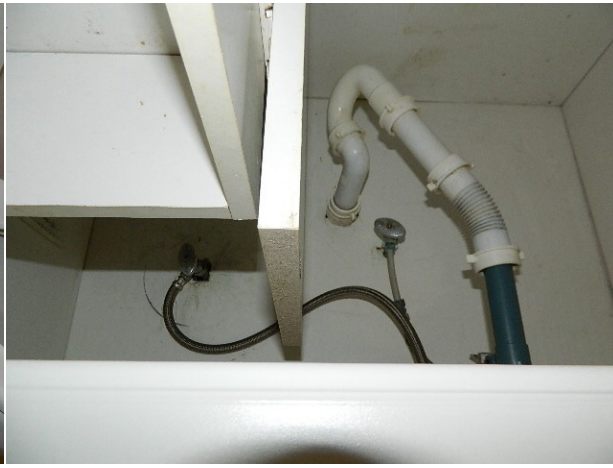
Master bathroom toilet and vanity water supply line shut offs

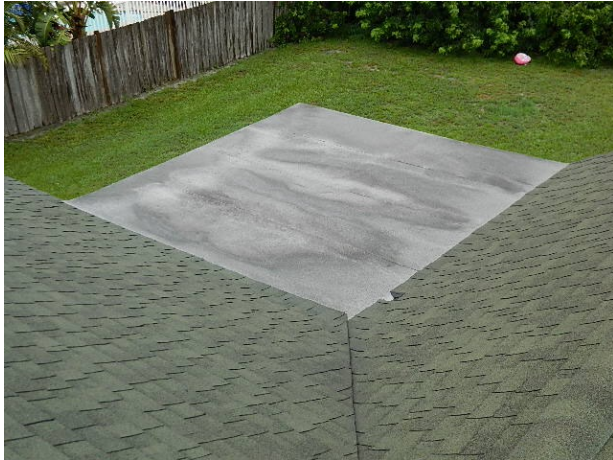
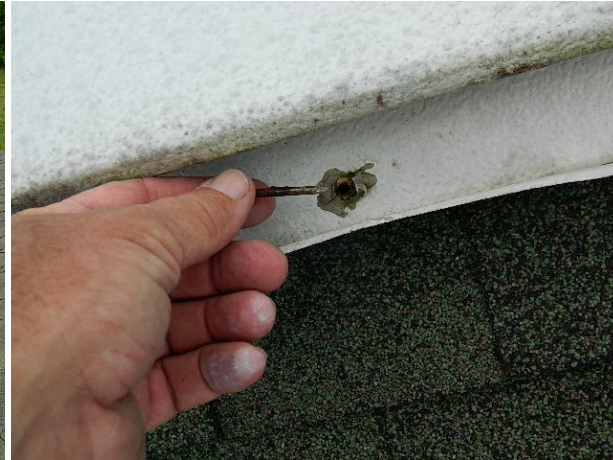
Fiberglass shingle and bitumen roof media along with loose ridge vent

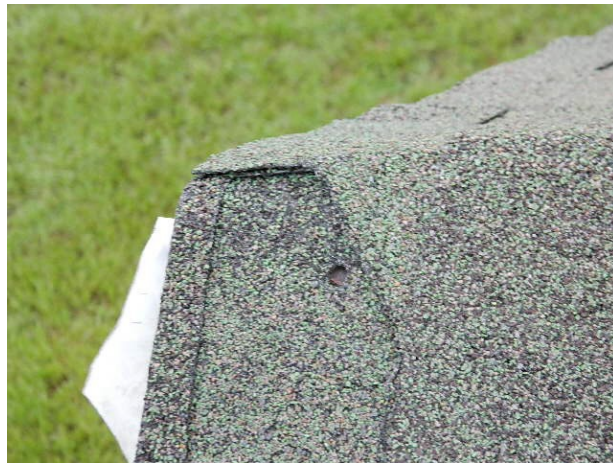
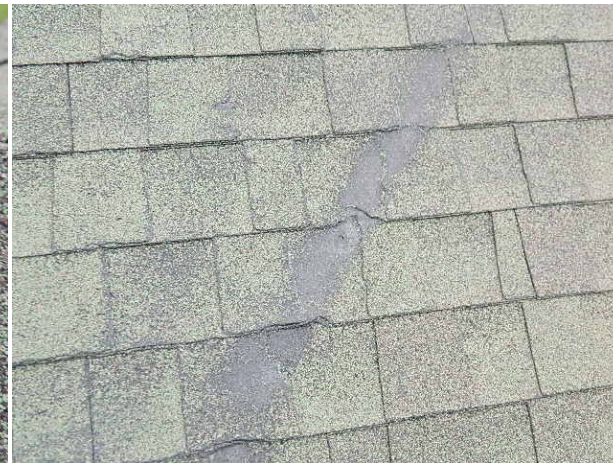
Missing ridge cap and shingle wear due to tree branches
