Uniform Mitigation Verification Inspection Form

Inspection Date: 06/09/2016		
Owner Information		
Owner Name: HECTOR RODRIGUEZ		Contact Person:
Address: 857 SW MCCOMB AVE		Home Phone:
City: PORT ST LUCIE	Zip: 34953	Work Phone:
County: ST LUCIE		Cell Phone: 772-708-1518
Insurance Company:		Policy #:
Year of Home: 1986	# of Stories: 1	Email: Melvrobinson@comcast.net

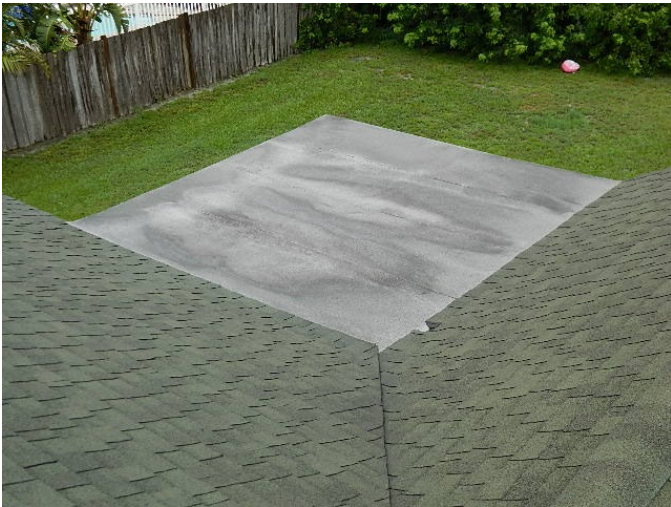
2.1 Roof Covering Type:	Permit Application Date	FBC or MDC Product Approval #	Year of Original Installation or Replacement	No Information Provided for Compliance
<input checked="" type="checkbox"/> 1. Asphalt/Fiberglass Shingle	7/20/2004		2004	<input type="checkbox"/>
<input type="checkbox"/> 2. Concrete/Clay Tile				<input type="checkbox"/>
<input type="checkbox"/> 3. Metal				<input type="checkbox"/>
<input type="checkbox"/> 4. Built Up				<input type="checkbox"/>
<input type="checkbox"/> 5. Membrane				<input type="checkbox"/>
<input type="checkbox"/> 6. Other _____				<input type="checkbox"/>

Roof covering, fiberglass shingle & bitumen roof

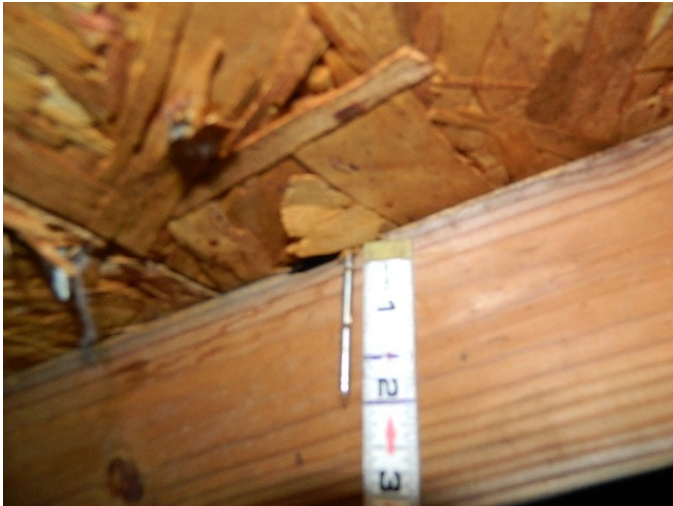
Roof deck attachment 8d nail

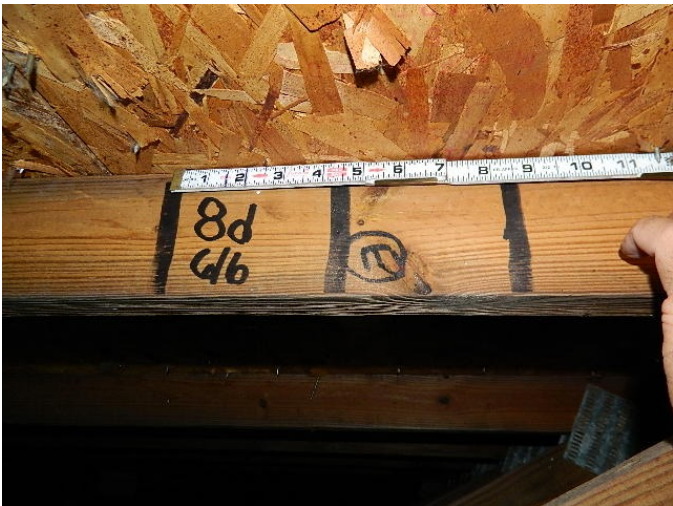
- ☒ C. Plywood/OSB roof sheathing with a minimum thickness of 7/16" inch attached to the roof truss/rafter (spaced a maximum of 24" inches o.c.) by 8d common nails spaced a maximum of 6" inches in the field. -OR- Dimensional lumber/Tongue & Groove decking with a minimum of 2 nails per board (or 1 nail per board if each board is equal to or less than 6 inches in width). -OR- Any system of screws, nails, adhesives, other deck fastening system or truss/rafter spacing that is shown to have an equivalent

Roof deck attachment 8d nail 6/6

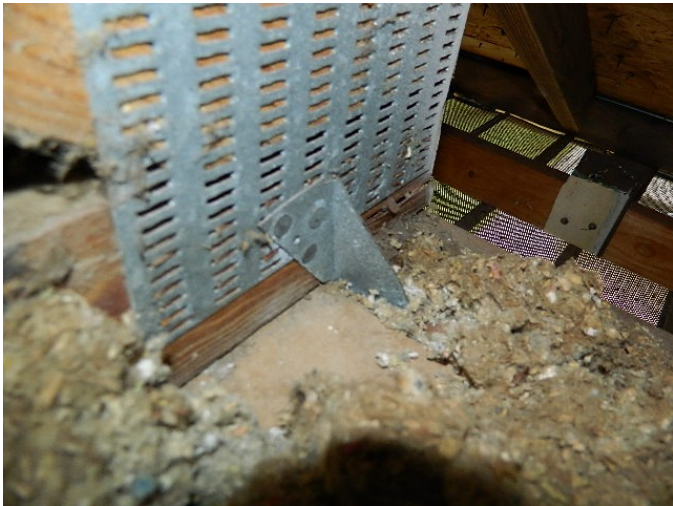
- ☒ Secured to truss/rafter with a minimum of three (3) nails, **and**
- ☒ Attached to the wall top plate of the wall framing, or embedded in the bond beam, with less than a ½" gap from the blocking or truss/rafter **and** blocked no more than 1.5" of the truss/rafter, **and** free of visible severe corrosion.
- ☒ B. Clips
 - ☒ Metal connectors that do not wrap over the top of the truss/rafter, **or**
 - ☐ Metal connectors with a minimum of 1 strap that wraps over the top of the truss/rafter and does not meet the nail position requirements of C or D, but is secured with a minimum of 3 nails.
- ☐ C. Single Wraps

Roof to wall connector w 3 plus nails
